**ABERDEEN COMMUNITY SERVICES BUILDING
FABRIC STUDY/FACILITIES ASSESSMENT REPORT**

**34 North Philadelphia Blvd.
Aberdeen, Maryland 21001**

Prepared For:
City of Aberdeen
Department of Planning and Community Development

Submitted:
October 21, 2015

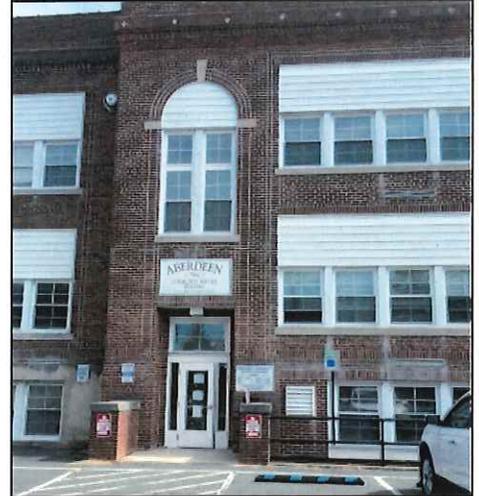
Based upon field observation and measurements of the existing structure, the entire exterior envelope appears to be 4" brick veneer backed by 8" masonry bearing walls. There appears to be no air space between the brick and concrete block, rendering it prone to moisture infiltration, and in fact, there was efflorescence observed over swathes of brick. The exterior mortar joints on brick veneer are not crumbling, however, long exposure to weather has eroded them.

Weathered Brick Joints and
Obvious Efflorescence

The exterior masonry walls are in good structural condition and need minor repairs to restore the character of the building. All brick and cast stone joints should be re-pointed. Testing on existing mortar and brick should be done prior to selecting new mortar type as some types of older bricks can quickly deteriorate when paired with new type-N mortars.

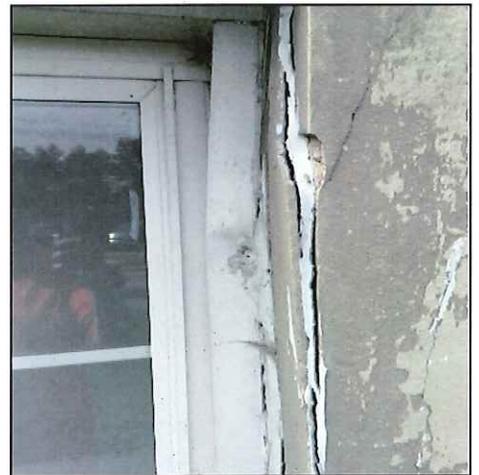
Some of the masonry near grade has been removed and patched with concrete or non-matching masonry, and should be replaced. Additionally, the lower level parging shows minor but extensive cracking and spalling around window and door openings. Some of the grade-level stone and cast stone show signs of significant erosion and vandalism, and should be repaired or replaced.

Exterior Lower Wall Crack/Parging
and Attempted Repair

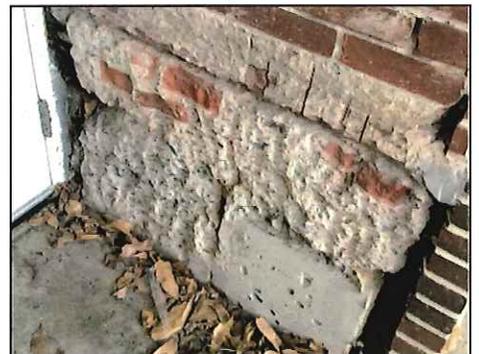
Exterior Degrading Brick and
Attempted Repair

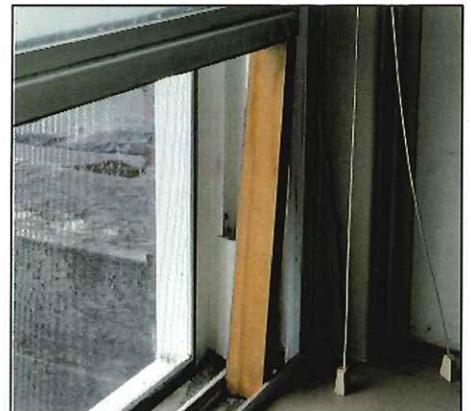
The windows are of consistent look and manufacture, but they are of poor quality and many of the windows suffer from hardware failure making them difficult or impossible to operate. There are multiple units with missing or cracked glazing, damaged sashes/frames, and rotted and leaking seals. Additionally, the existing windows are much smaller than the original masonry rough openings, and share the rough opening with un-insulated infill walls of aluminum siding. There are numerous windows that have been removed or modified for various HVAC and utility components, and in several cases, those penetrations are allowing water infiltration. Additionally, many of the interior sills and jambs show signs of seal failure and water infiltration. Selective demolition will reveal more information about how the windows were installed and what precautions were taken to mitigate moisture penetration during window replacement.

Inoperable Window Condition

We would recommend that all of the existing windows and infills be removed, and new commercial-grade energy-efficient windows that fill the complete rough opening be installed wherever possible. There is approximately 6,000 S.F. of windows in the project which would constitute a significant cost. Additionally, there may be cost and labor intensive remediation of the steel lintels required if any are found to be structurally compromised due to weathering.

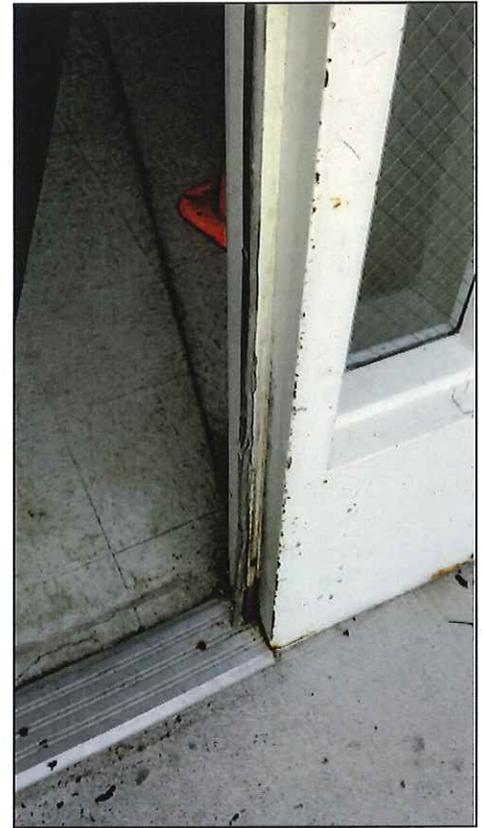
The existing exterior doors are a mix of wood doors and frames and hollow metal doors and frames. The glazed double entry/exit doors tend to be wood, and the unglazed single man doors tend to be hollow metal. The wood doors appear to be operable and in fair condition, and have been outfitted with wired glass. The wood door frames appear to be the original design, and while they appear weathered, they could be restored and modified to function appropriately. The hollow metal doors and frames show damage and signs of rust and corrosion. Weather seal failure and threshold failure is common amongst door openings, as well as locations where the door leaf no longer fits the frame correctly, and daylight is visible around the door leaf edges.

Damaged and Rusted Frame

We recommend all exterior wood doors be evaluated for restoration, and all hollow metal doors and frames be removed. All door hardware including but not limited to: levers, knobs, latches, pulls, plates, closers, panic hardware, and hinges should be removed and replaced with code-compliant hardware.

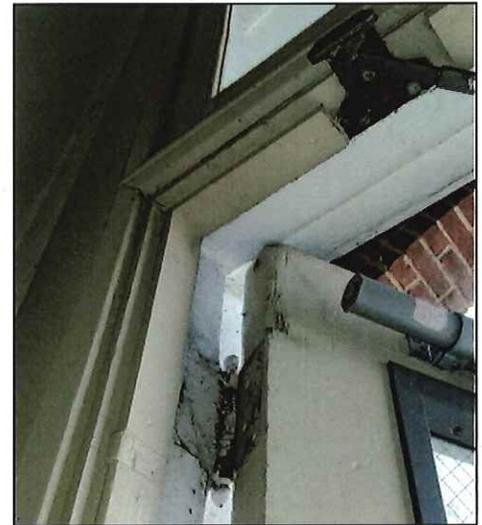
Door hardware is in poor condition and inconsistent across the exterior doors, and should be removed entirely. The door swing directions are consistent with the direction of egress, but some of the clear widths and minimum door leaf sizes need to be evaluated in a detailed code study to ensure they allow adequate egress width.

Damaged, Old and Rusted Hardware

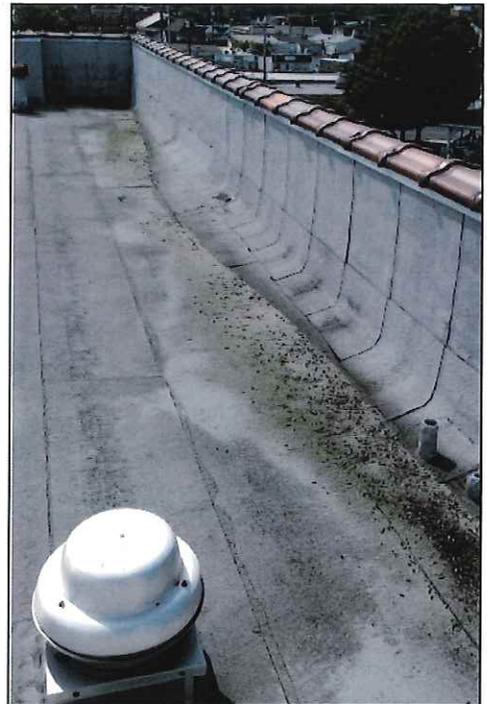
Stained Location from Ponding Water

Much of the existing flat and shingle roofs are in good condition and can be salvaged. Areas that are retaining water will need to be re-sloped to allow water to drain. Any small leaks and irregularities in the roofing and coping will need to be repaired. The roof has approximately 10-15 years of remaining lifespan and future replacement will be of moderate cost. The skylight should be removed, but should be replaced as an important historic detail.

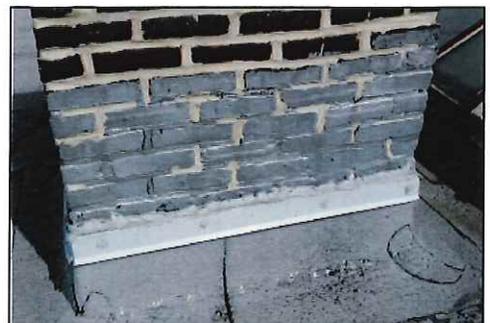
With the exception of minor patches, the roof and coping appear to be in fair condition. There is evidence of repair at several locations, but the repairs appear to be sound and recent. As evidenced by the observation of the roof structure over the north wing, there are portions of the high roof that are sagging and show obvious signs of ponding. There is evidence of structural sagging and ponding on the gymnasium roof near the east edge of the building. In the roof of the north wing, there is a large pitched skylight that appears to be structurally stable, but there is evidence of water infiltration at one corner. The skylight itself is in poor condition, with cracking or missing putty on the glazing and stained and weathered flashing.

Repaired Flashing and Jointing

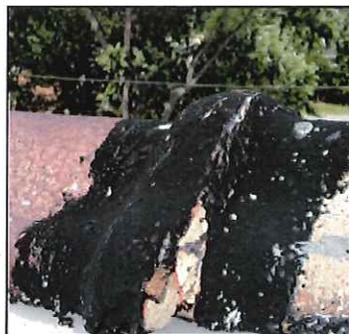
Patched Coping

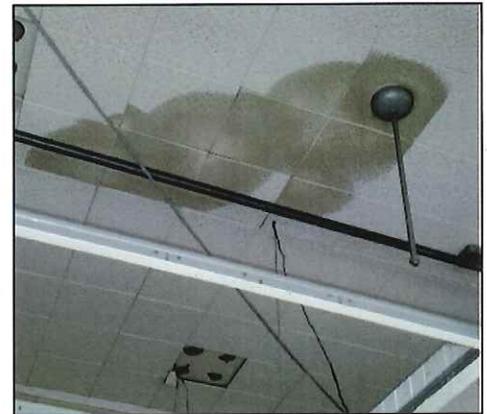
There are portions of ceiling throughout the building that show water damage; however, considering the condition of the roof this damage may be attributable to a mechanical or plumbing system failure or may pre-date the roof replacement.

Water Damage and Falling Hard Ceiling

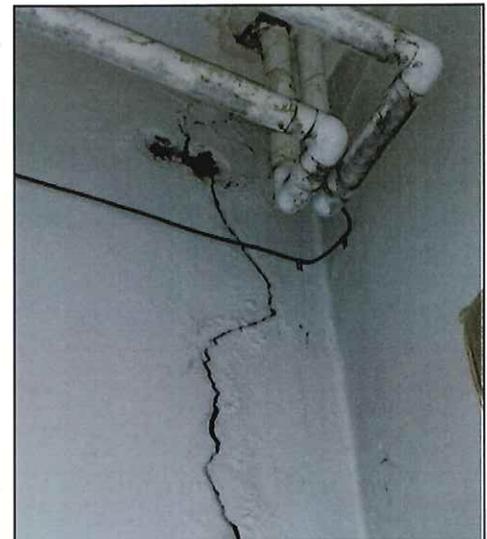
Water Cracking

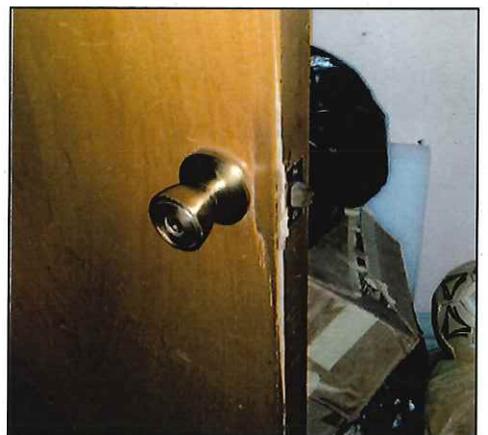
Damaged Door

In general, the interior corridor walls that were part of the original building design appear to be structurally sound, but most are covered in lead paint. It is our recommendation that these walls be stripped to the wood or masonry framing to allow for a full structural inspection and new finishes. The interior non-bearing walls are in various states of age and damage, and should likewise be stripped down to the rough framing. If it is not economically feasible to selectively demolish these walls, then we recommend the full removal of all non-structural interior partitions. The interior doors are also in various states of age and disrepair, and our recommendation is to remove all interior doors, frames, and hardware.

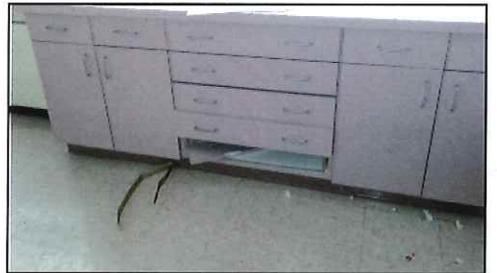
Worn Casework (2nd floor)

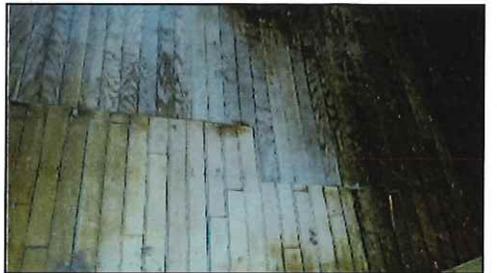
Worn Wood Floor (3rd floor)

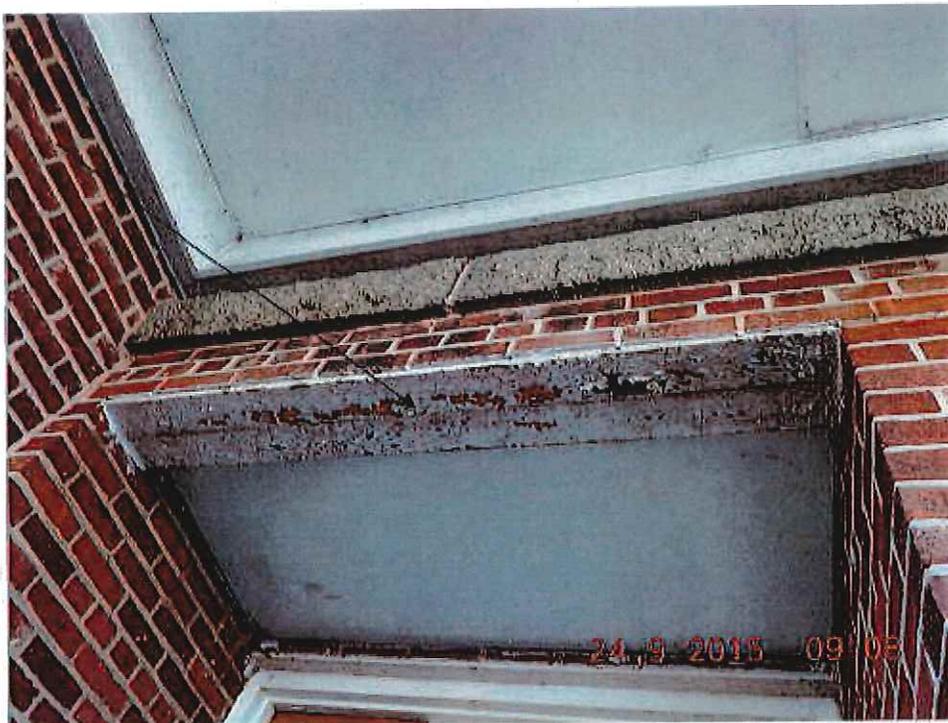
Photo 1 Exterior lintel on south side of rear by addition with lead paint in poor condition.

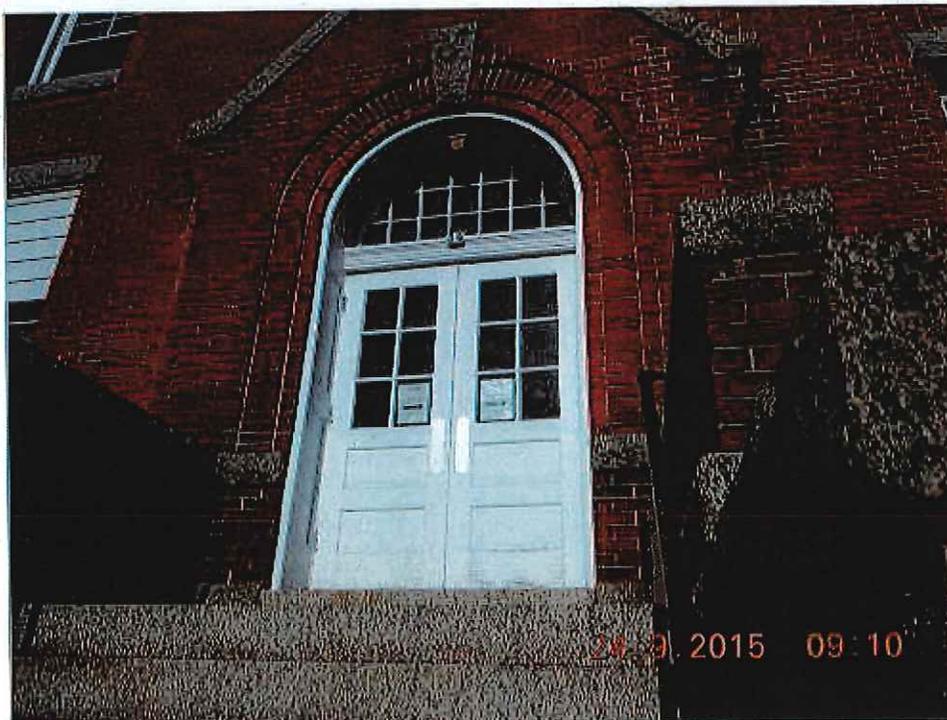
Photo 2 Door entrance with lead paint throughout on all surfaces.

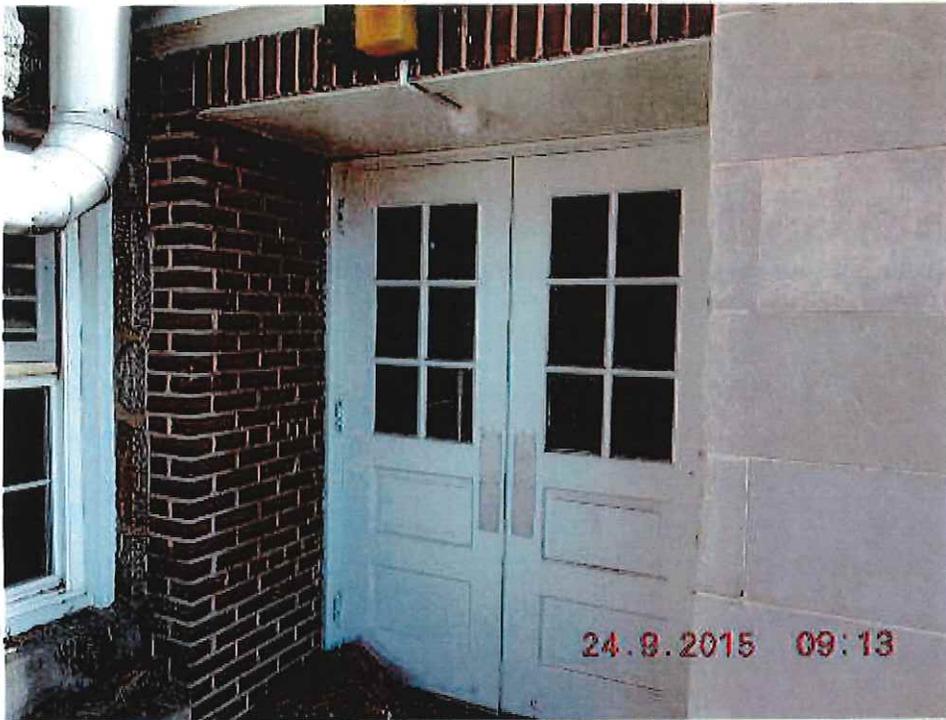
Photo 3 Lower level entrance with lead paint on wood and metal.

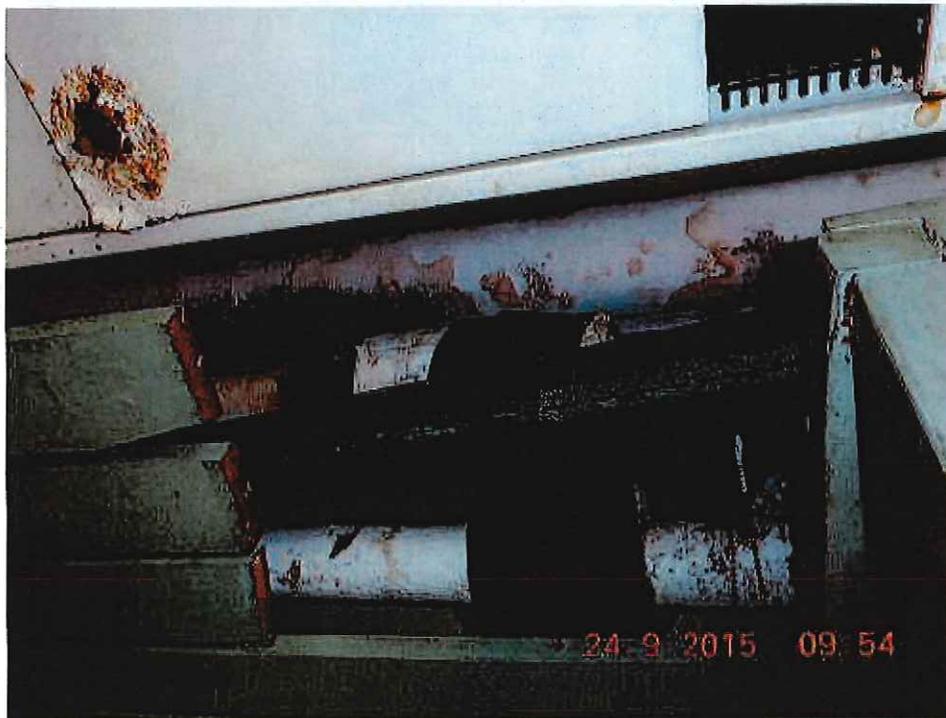
Photo 4 NO asbestos pipe insulation was identified.

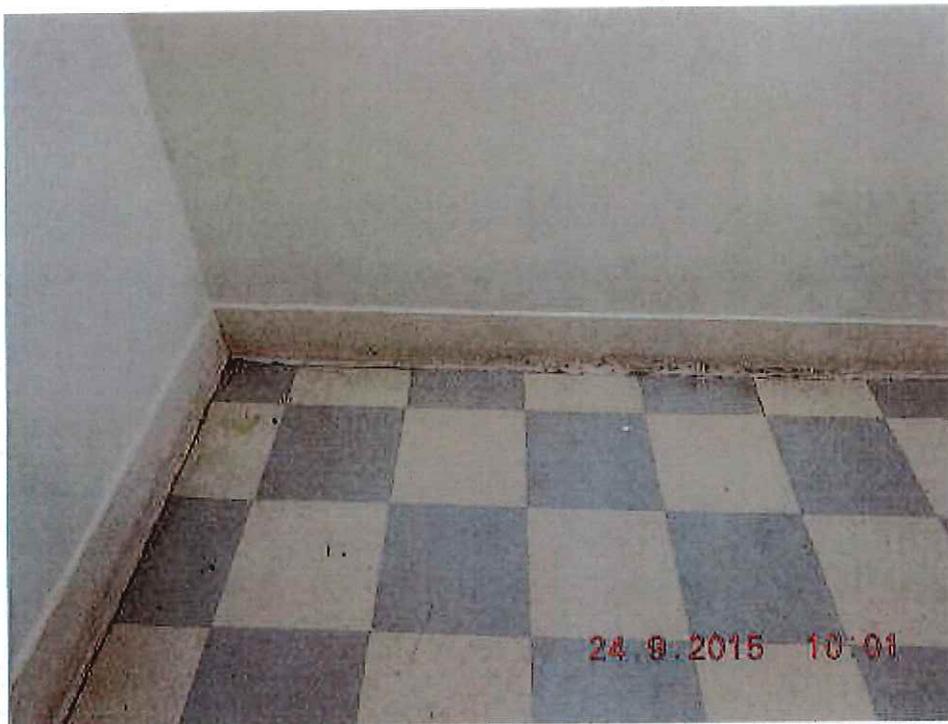
Photo 5 12" floor tile – negative. All 12" floor tiles were negative except those by the elevator lobby.

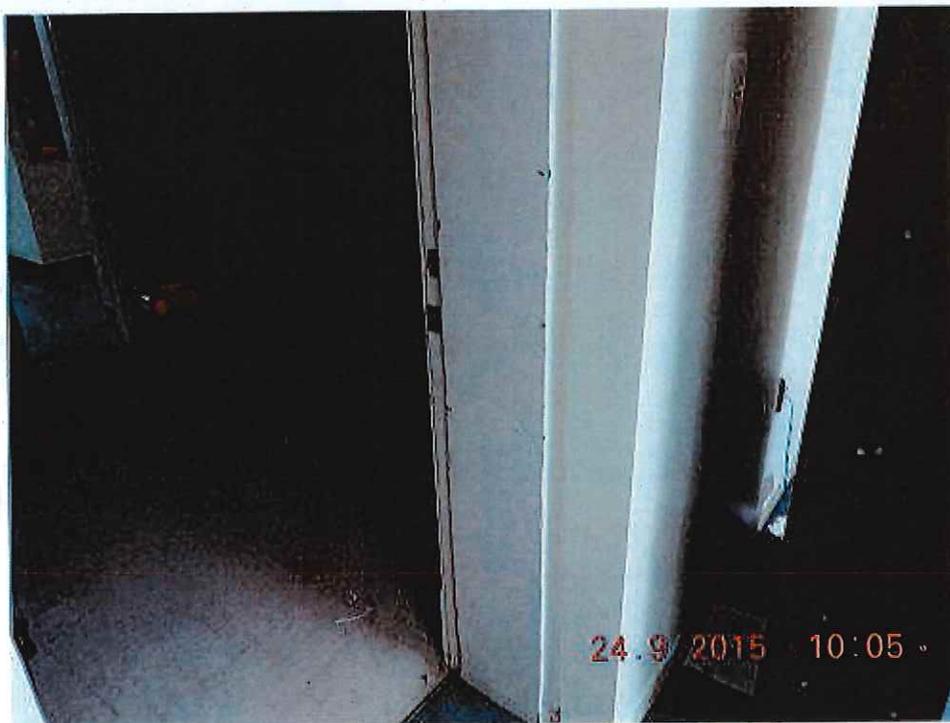
Photo 6 Lead paint on door trim, casings etc.

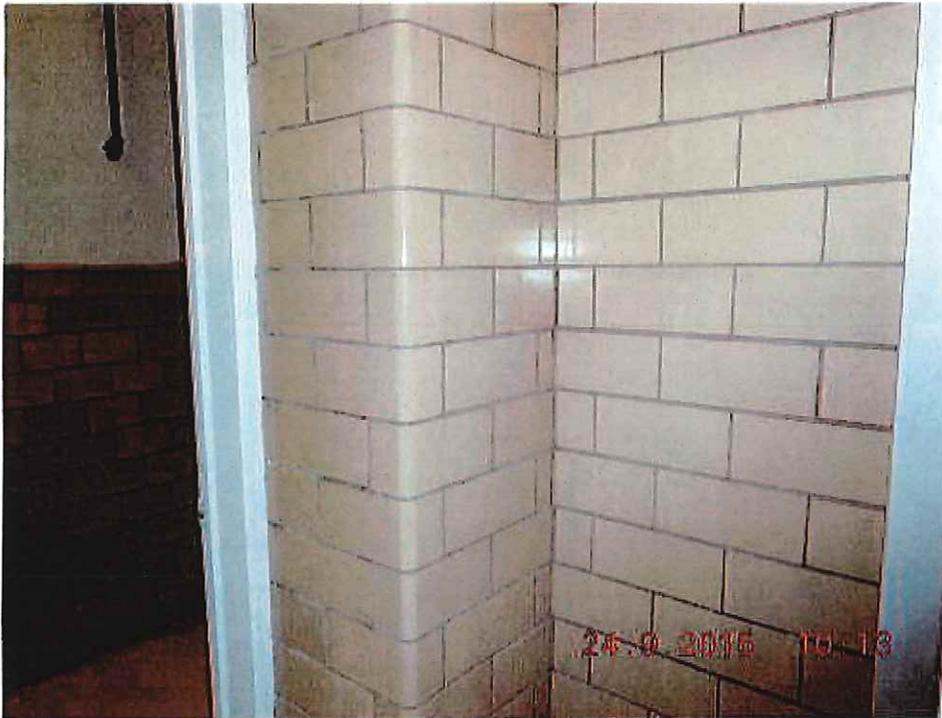
Photo 7 Kitchen glazed block wall has a lead paint component. NO other glazed block tested positive in the building.

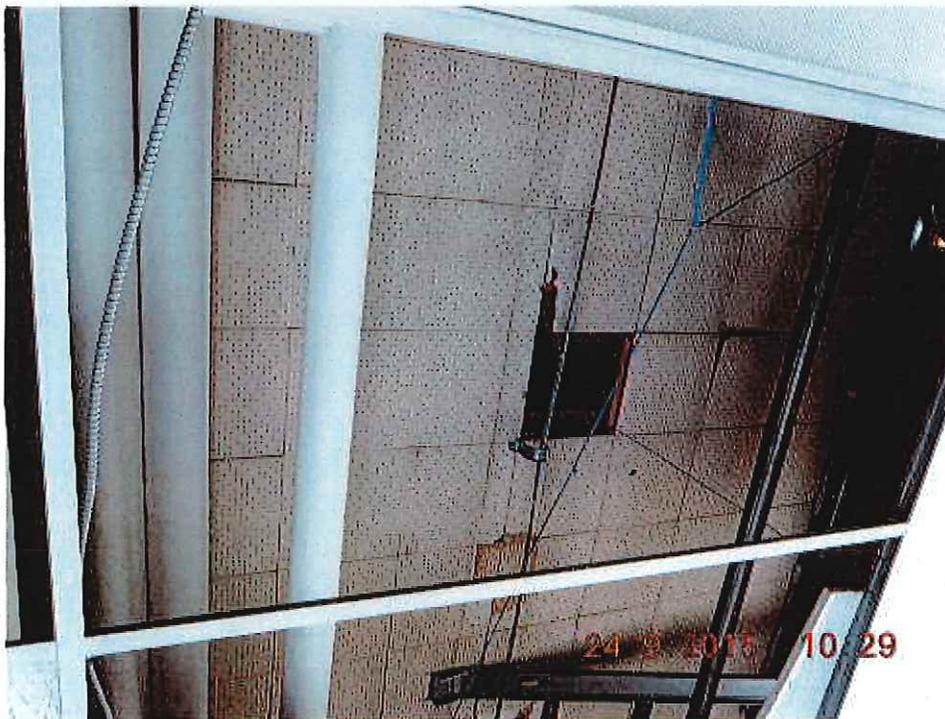
Photo 8 Spline ceiling tile was negative along with glue dots.

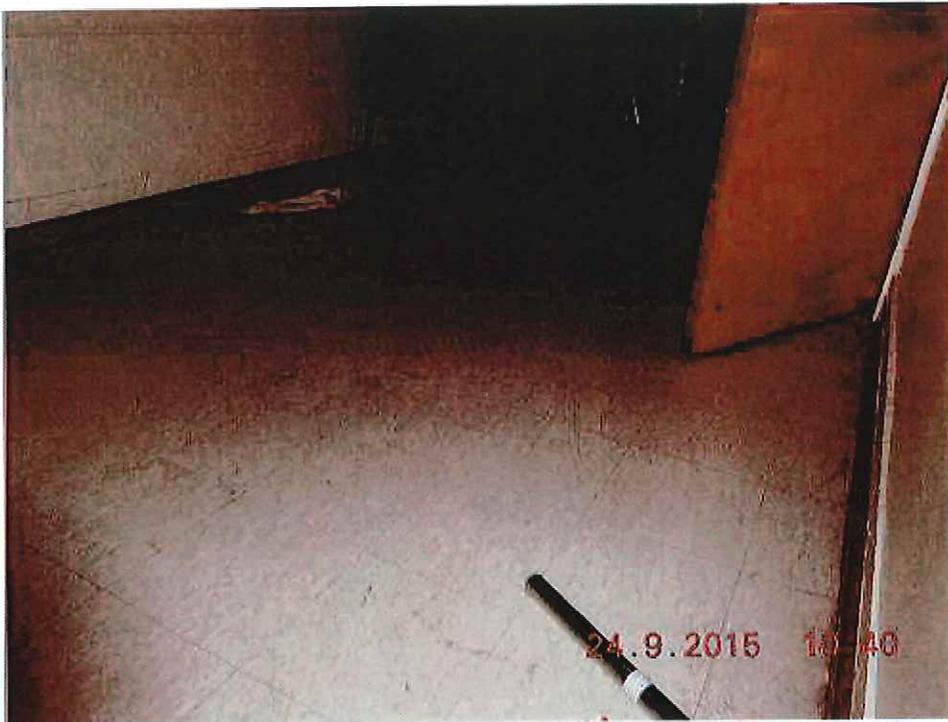
Photo 9 Non-asbestos 12" floor tile.

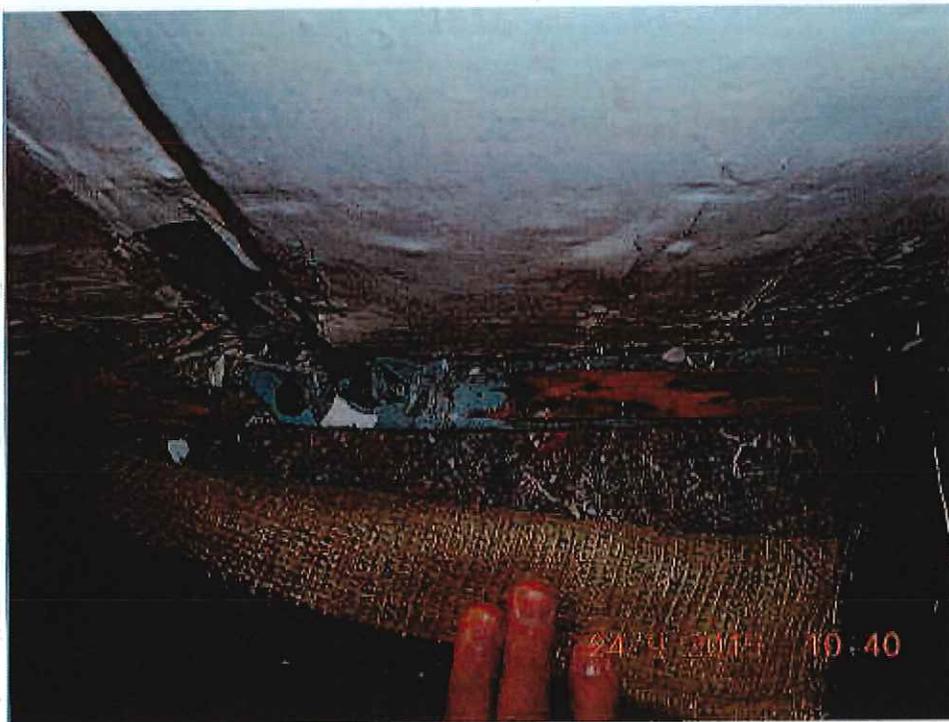
Photo 10 Nine (9") floor tile is present beneath most carpeting or beneath other 12" floor tile.

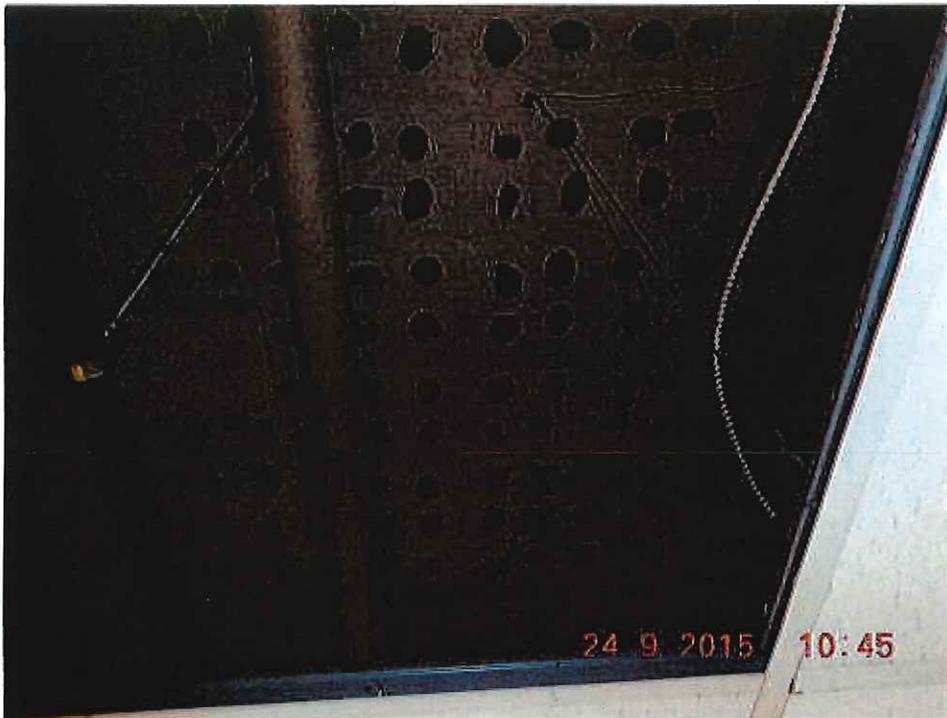
Photo 11 Glue dots were negative.

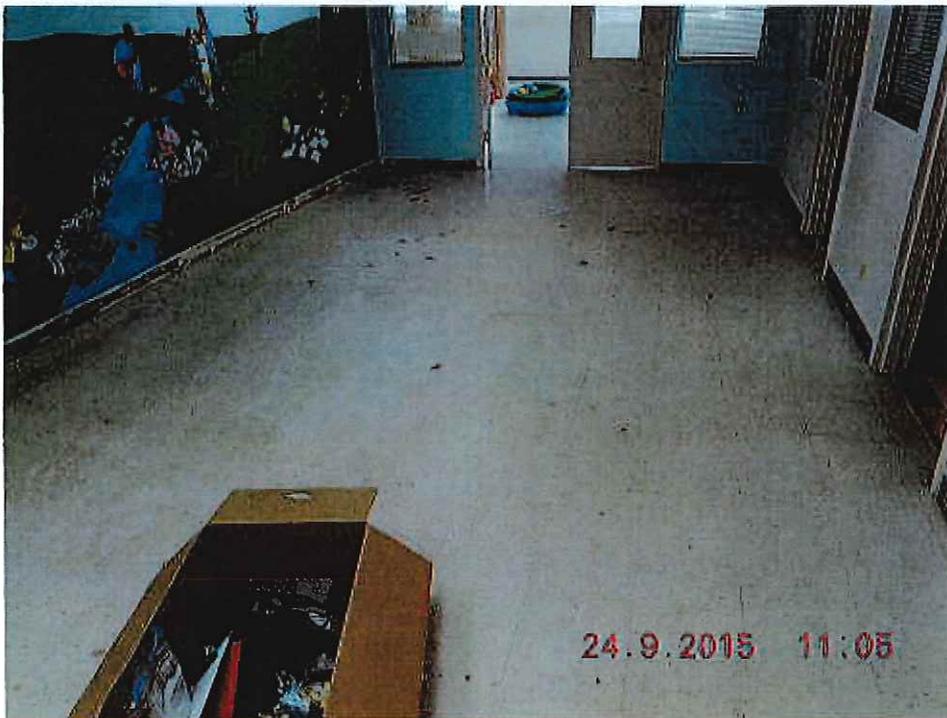
Photo 12 Much of this newer 12" floor tile is covering older 9" Vat/Mastic

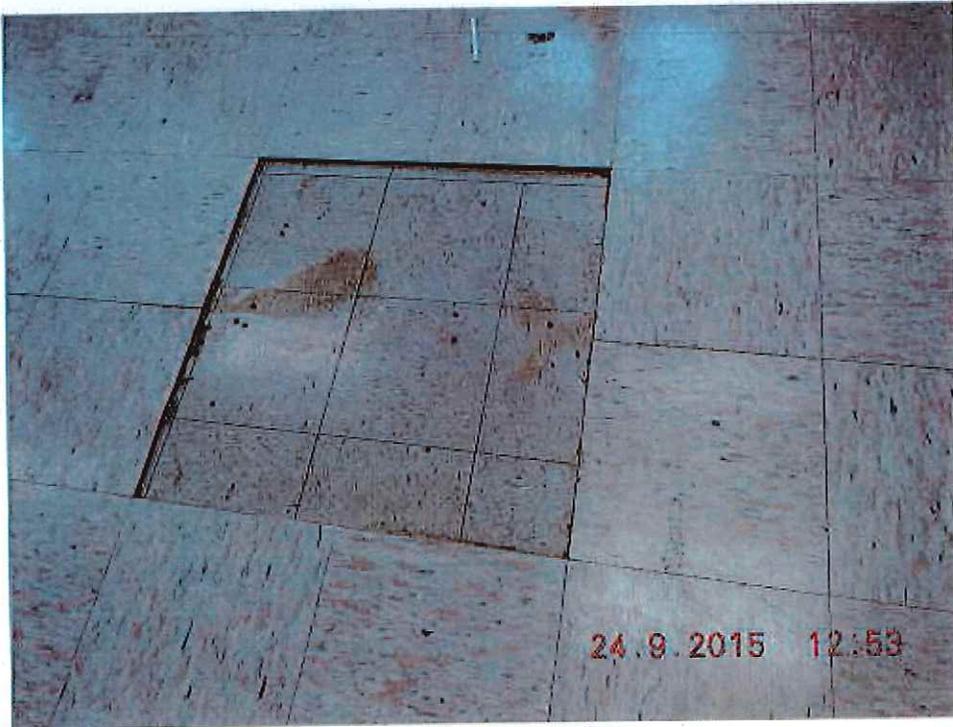
Photo 14 Typical with 12" VCT covering 9" VAT

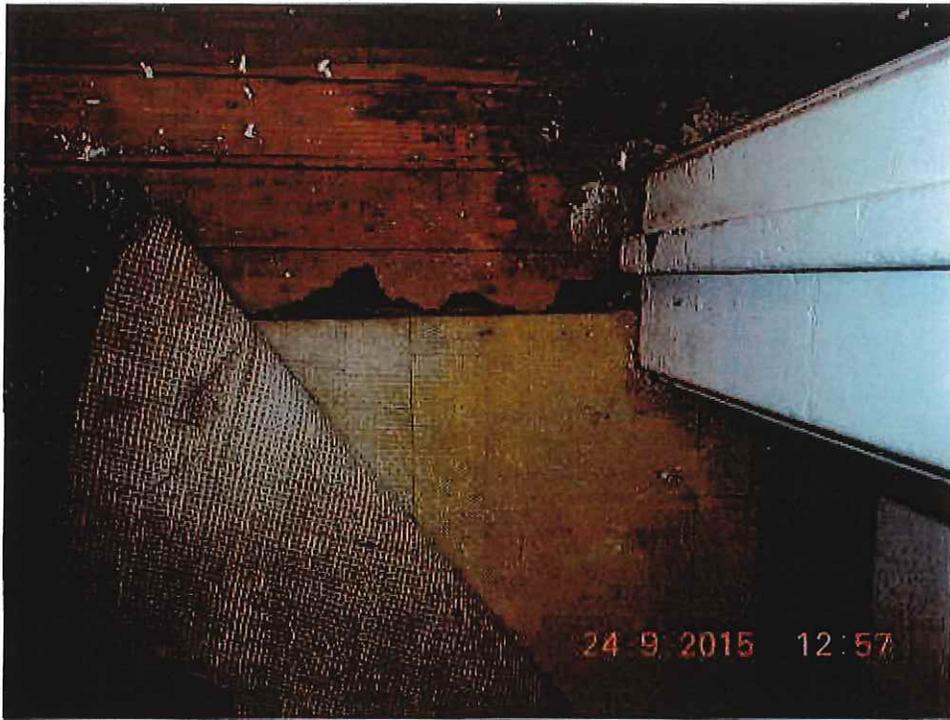
Photo 15 Typical with carpet covering 9" VAT

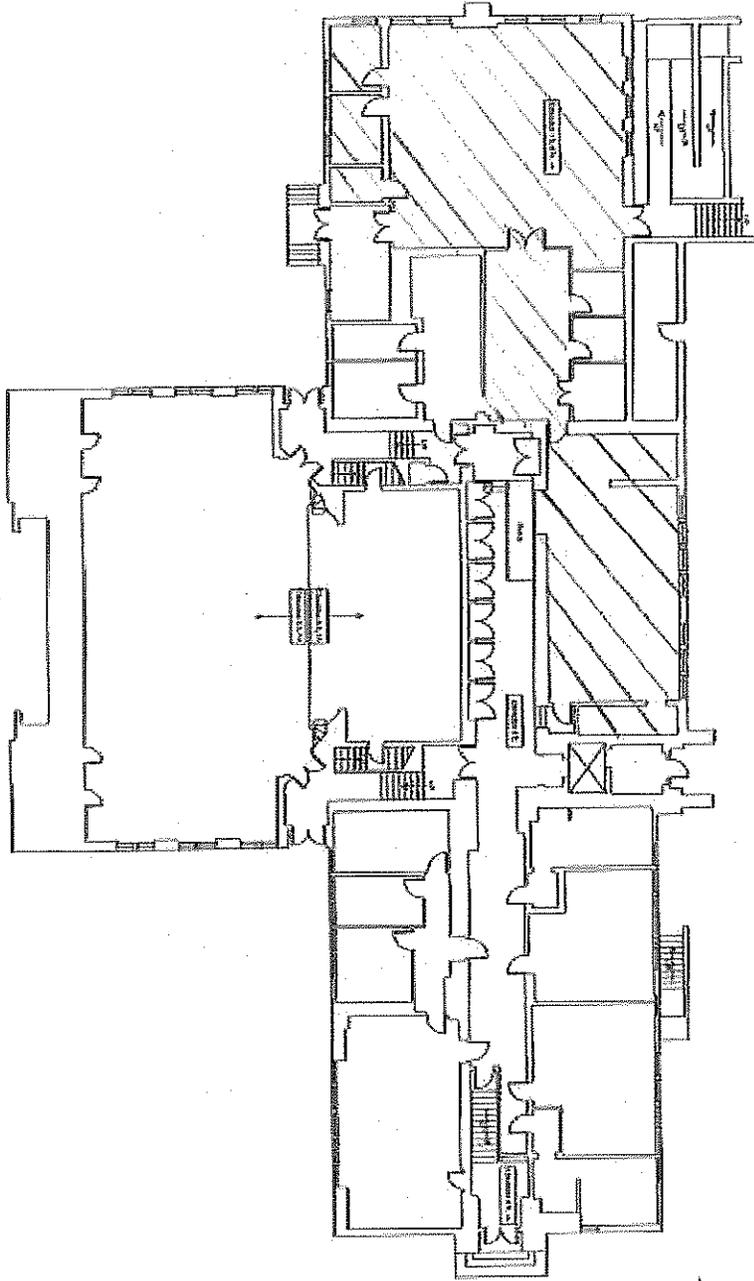
Drawing No.
 A1

VAT/MASTIC lies beneath carpet or VCT throughout

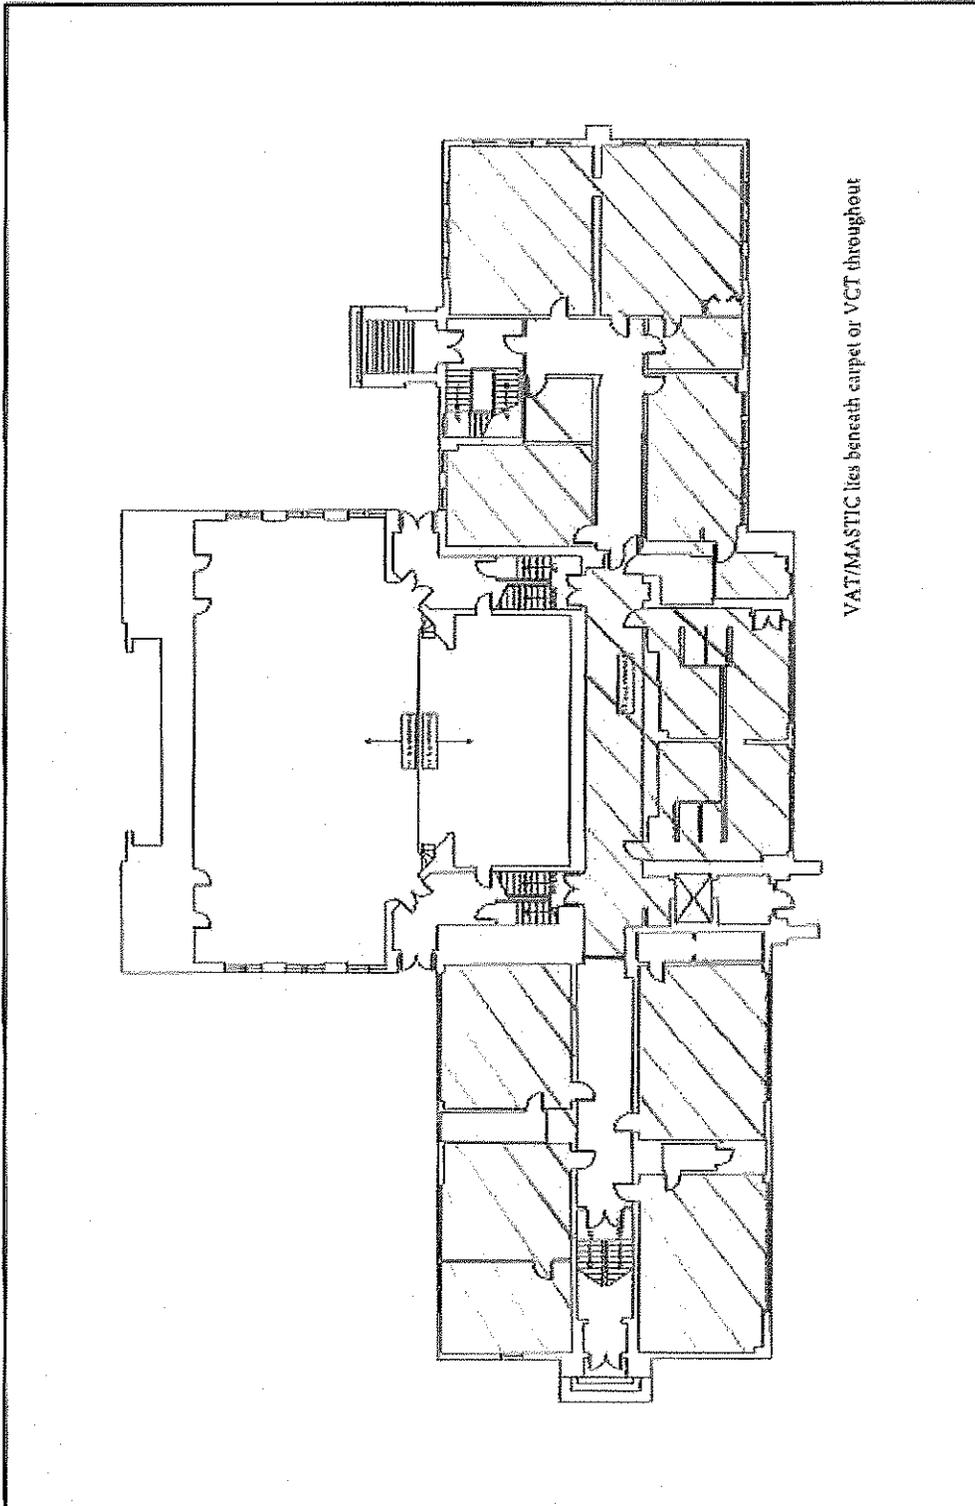
VAT/MASTIC lies beneath carpet or VCT throughout

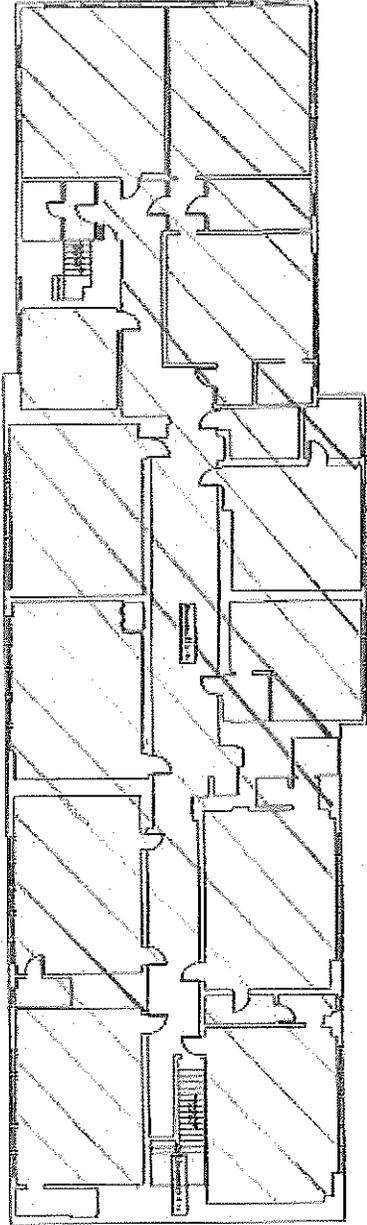
VAT/MASTIC lies beneath carpet or VCT throughout
