**ABERDEEN COMMUNITY SERVICES BUILDING
FABRIC STUDY/FACILITIES ASSESSMENT REPORT**

**34 North Philadelphia Blvd.
Aberdeen, Maryland 21001**

Prepared For:
City of Aberdeen
Department of Planning and Community Development

Submitted:
October 21, 2015

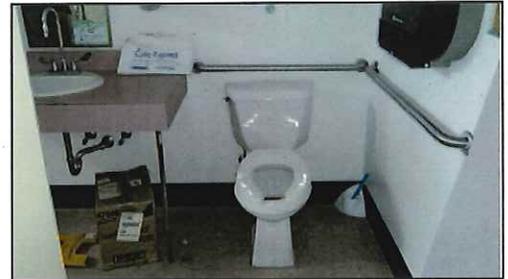
Non-Compliant Toilet Clearance

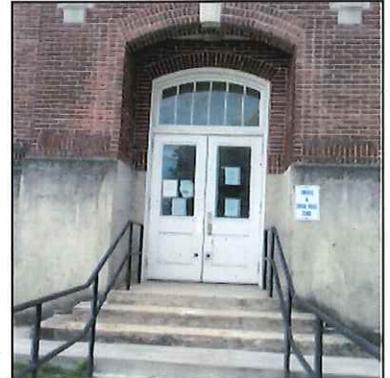
Exterior Stair at North Wing

The north exterior entrance stair is concrete with steel pipe handrails, and is in solid, but weathered condition. The nosings are worn and spalling in many places, but there are no major visible structural concerns. Tread and riser dimensions appear to be within the allowable code requirements. The steel pipe handrails are structurally sound, but are in violation of height and extension requirements.

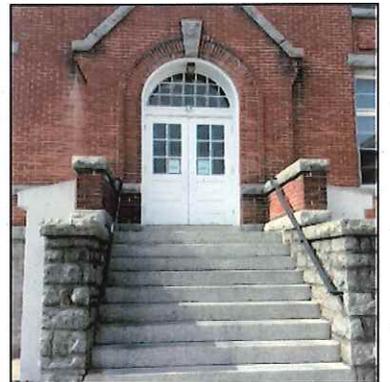
Exterior Stair at South Wing

The exterior stair on the eastern side of the south wing is comprised of stone treads and risers with stone wall guards and steel pipe handrails. The masonry appears to be structurally sound and the treads and riser dimensions appear to be within allowable code requirements. The steel pipe handrails are structurally sound, but are in violation of height and handrail extension requirements. The width of the stair may require the addition of an additional handrail down the centerline of the stair. The height of the masonry wall acting as a guard may need to be modified or supplemented to provide adequate fall protection. Under this stair, there are two flanking stairs that provide access to the lower level via a shared landing located directly below the landing of the entrance stair. These stairs are concrete and also appear to be dimensionally acceptable, but are in violation of handrail requirements.

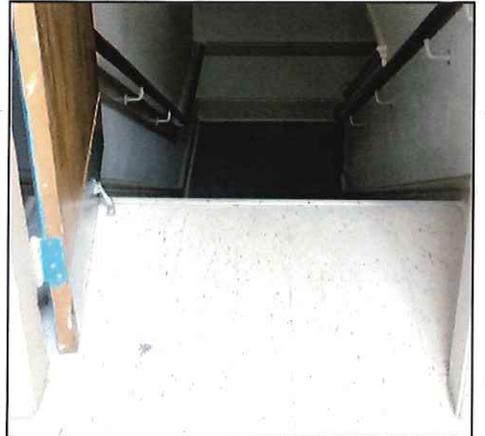
Non-Code Compliant Landing Size

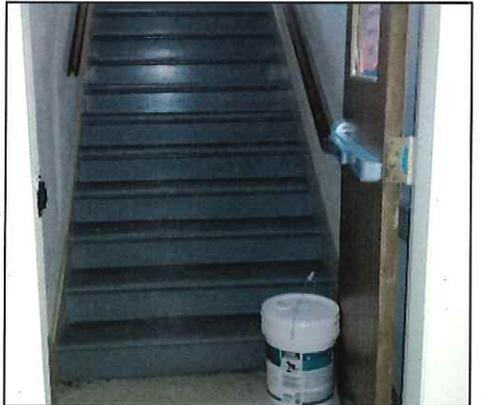
Non-Code Compliant Handrail,
Landing, & Tread Material

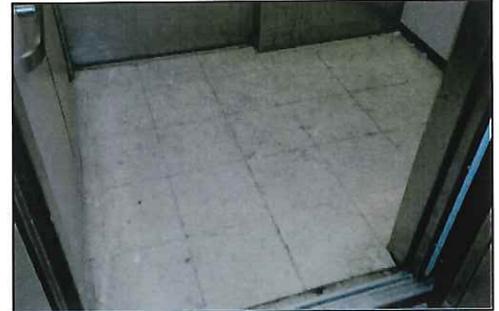
Elevator

Dimensionally, the elevator meets ADA size requirements. It appears to be in good working condition and has a recent certification, but cab finishes need replacing and an inspection performed. The elevator machine room is on an upper floor and is not accessible from the elevator lobby, however, it is clean and the equipment appears to be in good condition.

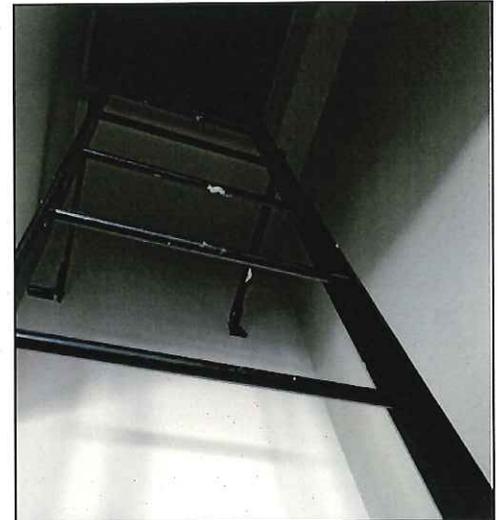
Ship's Ladder/Roof Access

Roof access is gained through a hatch and ship's ladder that connects the third floor to the roof. Access to this hatch is only through the security office that lies adjacent to the north stair on the third floor. The ship's ladder and hatch are securely fastened to the structure and in general, appear to be in good condition – we were able to safely use it to access the roof – however, there are signs of water damage at the bottom of the ladder.

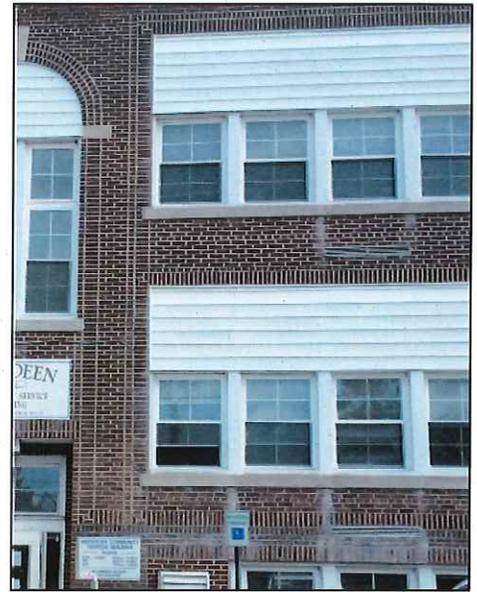
Lowered Original Window Openings

- There were then one or more major interior renovations that most likely occurred between the 1960's and 1990's. One such renovation was a large scale systemic upgrade in which the window heads were lowered to accommodate drop ceilings and the new HVAC systems installed above those ceilings. Shorter windows were installed and the space above was infilled with aluminum siding.

We would recommend that all of the existing windows and infills be removed, and new commercial-grade energy-efficient windows that fill the complete rough opening be installed wherever possible. There is approximately 6,000 S.F. of windows in the project which would constitute a significant cost. Additionally, there may be cost and labor intensive remediation of the steel lintels required if any are found to be structurally compromised due to weathering.

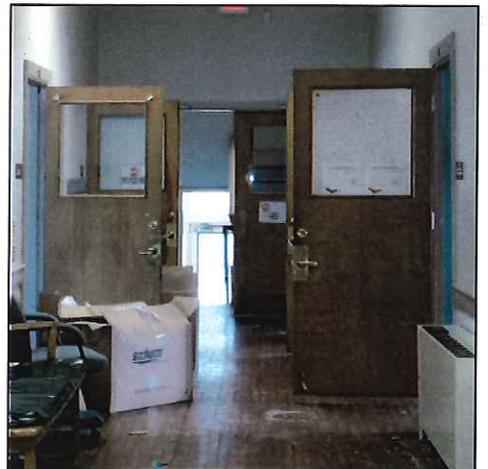
Interior Doors

In general, the interior corridor walls that were part of the original building design appear to be structurally sound, but most are covered in lead paint. It is our recommendation that these walls be stripped to the wood or masonry framing to allow for a full structural inspection and new finishes. The interior non-bearing walls are in various states of age and damage, and should likewise be stripped down to the rough framing. If it is not economically feasible to selectively demolish these walls, then we recommend the full removal of all non-structural interior partitions. The interior doors are also in various states of age and disrepair, and our recommendation is to remove all interior doors, frames, and hardware.

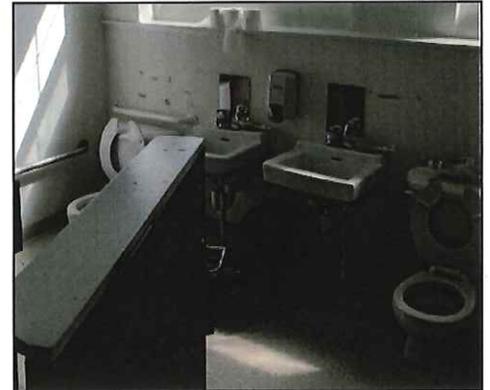
Children's Toilet Room

Most of the toilet rooms are undersized and their dimensions, clearances, and accessories are not ADA-compliant. The fixture and accessories are in poor condition, and inconsistent throughout the building. We recommend the full removal of all fixtures, finishes, and accessories in the existing toilet rooms, and code compliant toilet rooms be integrated into the new building program.

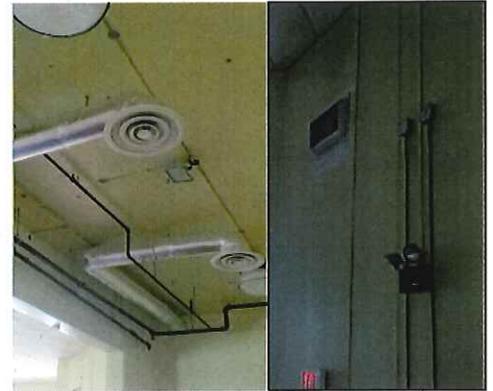
Wall Diffusers & Return Grilles (Gym)

The gym air handling and outdoor condensing units have reached the end of their equipment lifespans and should be replaced. As part of the replacement, the distribution ductwork for the space should be augmented for better comfort. Also, the amount of outside air required by code should be re-evaluated for compliance.

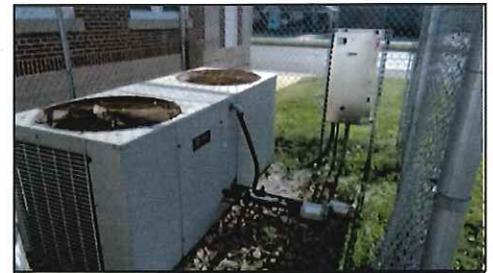
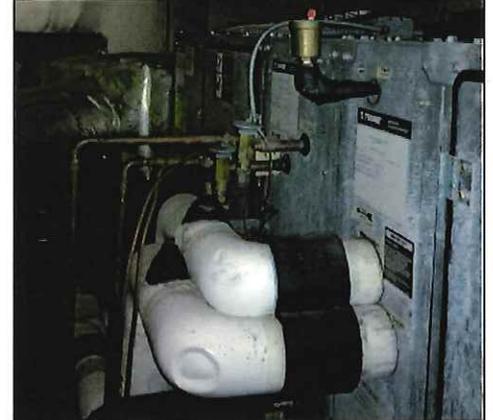
Constant Volume Air Handling Units

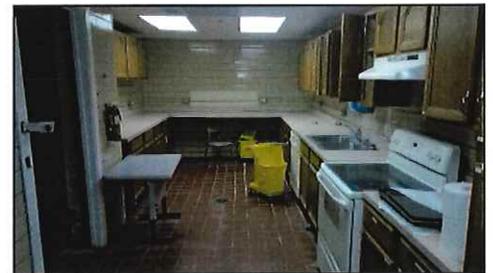
The daycare kitchen exhaust hood is a residential type that is ducted to the front of the building. The remaining exhaust systems throughout the building consist of inline fans that are ducted directly outside through wall vents.

Daycare Kitchen

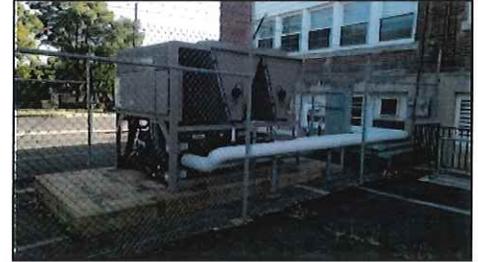
A York air-cooled chiller installed on the northwest side of the building is used to produce chilled water for air conditioning. The 90-ton chiller is approximately six years old and is in good condition.

York Air-Cooled Chiller

The existing air cooled chiller is in good condition and should be reused to provide cooling for the building. As it has not been used for some time, it should be examined by service personnel to make sure that it is in peak operating condition.

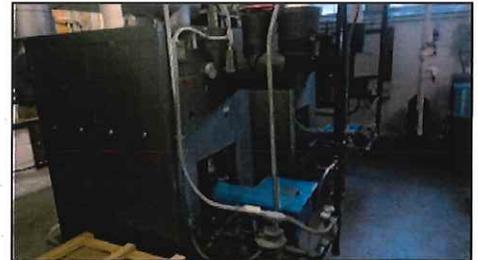
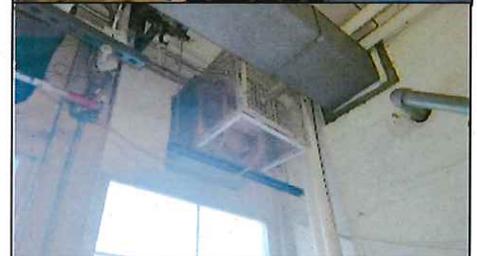
Hot water for the two-pipe system is provided by two gas-fired, forced draft, cast iron boilers manufactured by H. B. Smith. Each of these boilers can supply 1,000 mbh of heat and are approximately 25 years old. Despite their age, the boilers are in good condition. Boiler products of combustion are exhausted to the roof via a chimney. Combustion air for the boilers is brought in by two local intake fans located in the boiler room. Boilers of this type are only 70% efficient.

Boilers and Intake Fan

The gas-fired, forced draft boilers have reached the end of their equipment lifespan and should be replaced. Higher efficiency boilers should be specified but the type of equipment selected may be hampered by the size of the existing chimney. If condensing boilers are to be used, the chimney should have a liner installed.

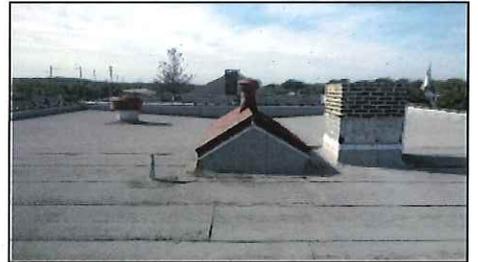
Boiler Exhaust Chimney

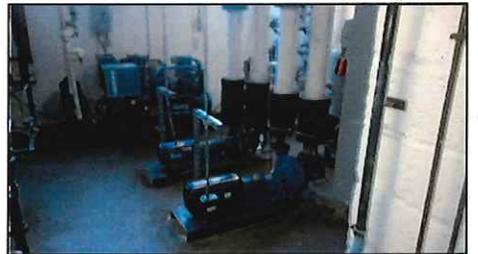
The pumps used in the two-pipe system and the piping system itself appear to be in good condition with all insulation in place.

Two-Pipe System - Pumps

The pumps are base-mounted, end-suction configuration. In general, the pumps are of high quality, however, they are approximately 20 years old and are near the end of their lifespan. Given that refurbishing the pumps will be only slightly less expensive than replacing them, new pumps should be installed and sized for the building's new function.

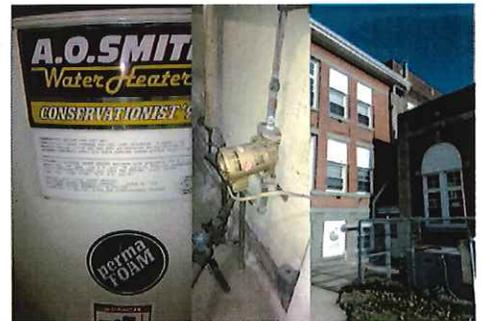
The building has a single, gas fired domestic water heater located near the kitchen on the first floor. The water heater is an A.O. Smith Model FS-75-202 with a 75 gallon storage capacity and heating input of 75,100 BTUs. The water heater appears to be in good condition, but is very old as it was manufactured in 1991. The system includes a circulating pump. Products of combustion from the water heater are exhausted out the Pulaski Highway side of the building via a duct to the roof.

Water Heater, Circulating Pump and Exhaust Duct

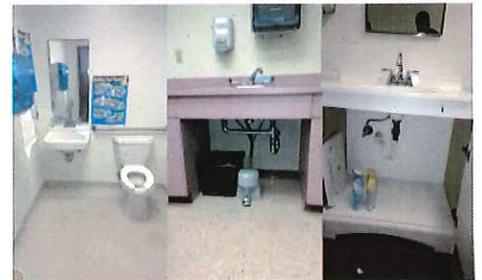
Plumbing fixtures are in good condition.

Plumbing Fixtures

The plumbing fixtures are in good condition and could be reused if desired. Plumbing piping and sanitary mains can be reused, but should be closely inspected during any renovation due to their age. Piping sizes should be re-evaluated based on the final architectural design.

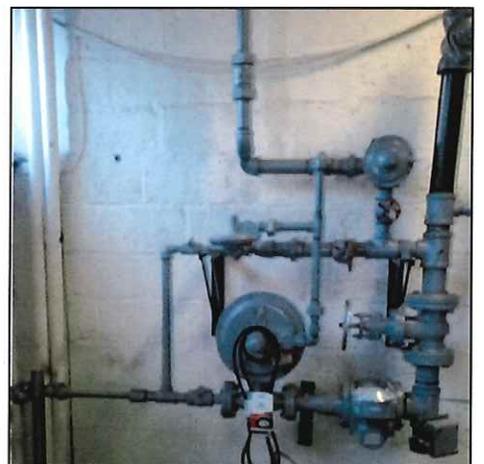
The 1" high pressure natural gas service is brought into the facility from Howard Street. From there, distribution piping runs to the mechanical room boilers and building domestic water heater. The gas regulator, meter and piping are all in good condition.

Natural Gas Regulator, Meter,
and Piping

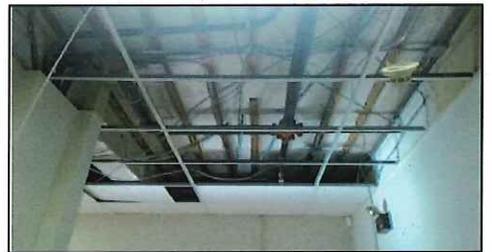
The sprinkler system is in good condition. The system, however, should be re-evaluated and modified based on the final architectural design and use of the building. Also, a hydrant flow test should be completed to confirm flows and pressures available to the system.

Sprinkler System Beyond Drop Ceiling

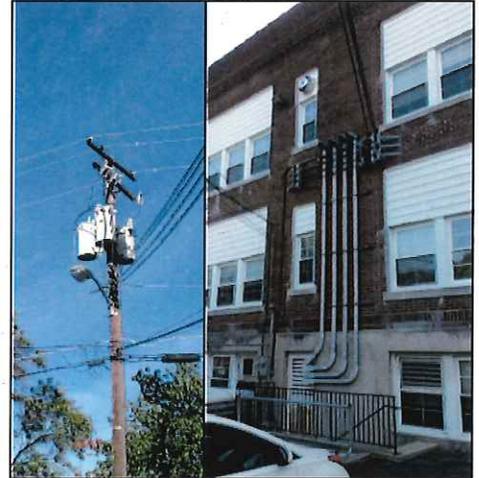
At the back of the building, on Howard Street, there are three pole-mounted transformers configured in a 208 Volt, 3 phase, WYE service that is run overhead to four weatherheads and conduits running down the building. The service then penetrates the exterior wall into an existing wiring trough located in the existing mechanical room in the basement. The electrical conduits and weatherheads appear to be in good condition.

Pole Mounted Transformers and Conduit Running into Building

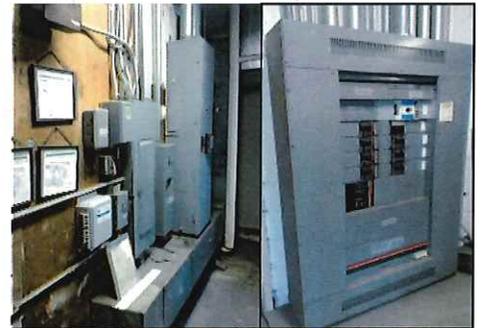
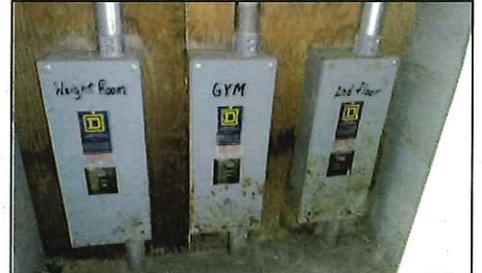
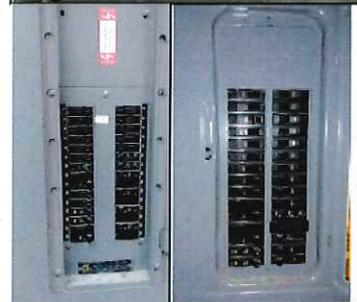
A majority of the panel boards are dated 1989 as installation date. The electric service is provided by Baltimore Gas & Electric Company. The existing service entrance rated enclosed circuit breaker enclosures have accumulated rust.

Panel Boards and Circuit Breakers

The existing electrical service appears to be of adequate size for the use of the building. Existing panel boards and service entrance rated enclosed circuit breakers are recommended to be replaced due to age. All electrical wiring devices throughout the building should be replaced due to wear and tear.

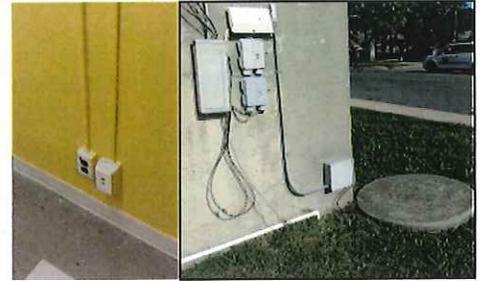
Existing receptacles and tele/data outlets are located throughout the building in walls and utilize Wiremold in areas. The existing receptacles and tele/data outlets located throughout the building are old and worn. The existing tele/data utility service enters the north side of the building, fed overhead from an existing utility pole and then terminates on demarcation board located in basement mechanical room. Existing telephone service is marked Bell Atlantic.

Receptacles and Tele/Data Outlets

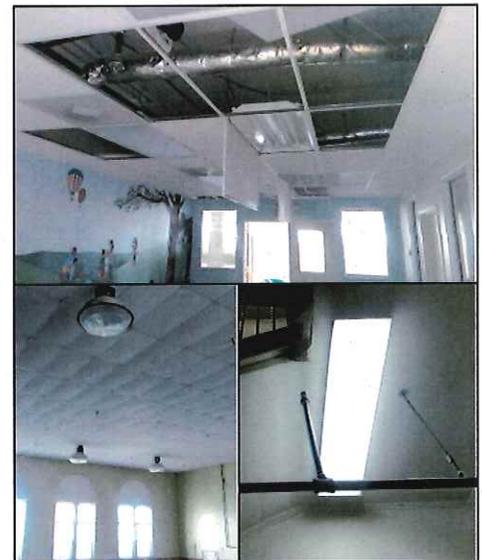
A majority of the existing lighting throughout the building consists of 2'x4' fluorescent troffers, 4' wraparounds and downlights utilizing fluorescent T8 lamps and compact fluorescent lamps respectively. In the existing gym, metal halide high-bay fixtures are utilized. All lighting has manual light switches for control. The lighting should be replaced.

Interior Lighting Fixtures

We recommend replacing all inefficient interior and exterior fluorescent and incandescent lighting fixtures with new LED type fixtures and new lighting controls. The controls should include occupancy sensors, photocells, time clocks and dimming controls to meet Code requirements. All battery backup emergency fixtures should be replaced with emergency backup integral to fixtures. All exit signage should be replaced with new LED type exit signs with battery back-up.

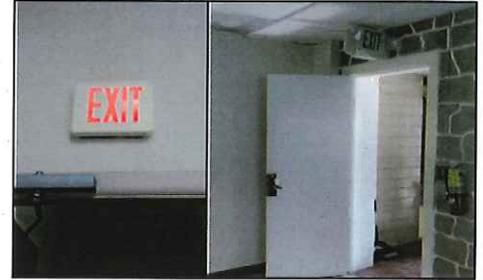
Existing exit signs are ceiling and wall mounted throughout the building. Exit signs typically are LED with white thermoplastic housings, red lettering and battery backup for emergency operation. There are a few locations where the exit sign is a combination exit/emergency light fixture with green lettering. In other locations, the exit sign has an aluminum housing with red letters and an incandescent lamp source. The exit signs are old and should be replaced.

Ceiling and Wall-Mounted Exit Signs

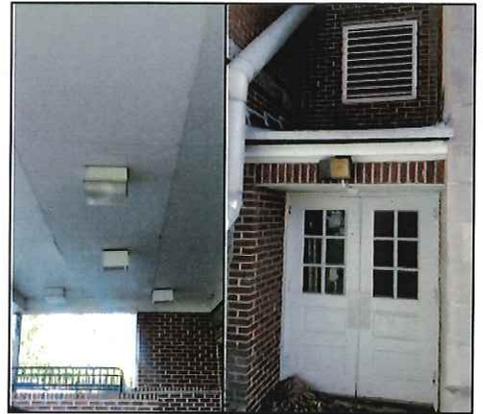
Existing exterior fixtures consist of ceiling and wall mounted metal halide fixtures. Existing exterior fixtures located overtop of exit doors are worn and their lenses are yellowed. Existing ceiling mounted fixtures at daycare canopy are different fixtures which do not match. These fixtures should be replaced.

Exterior Lighting Fixtures

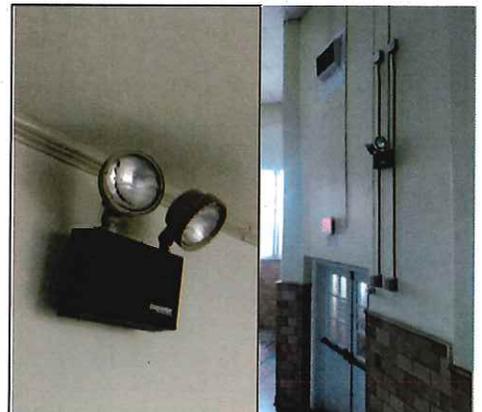
Emergency lighting fixtures with battery back-up are scattered throughout the building for emergency egress lighting. Existing emergency fixtures are old and using incandescent lamp sources. The emergency lights should be replaced.

Emergency Lighting Fixtures

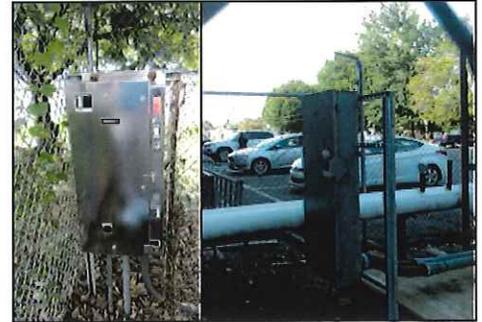
The existing disconnecting means to the HVAC equipment looks to be in excellent condition.

HVAC Equipment Disconnects

Existing disconnect switches feeding mechanical HVAC equipment look to be in excellent condition and we recommend keeping switches for reuse.

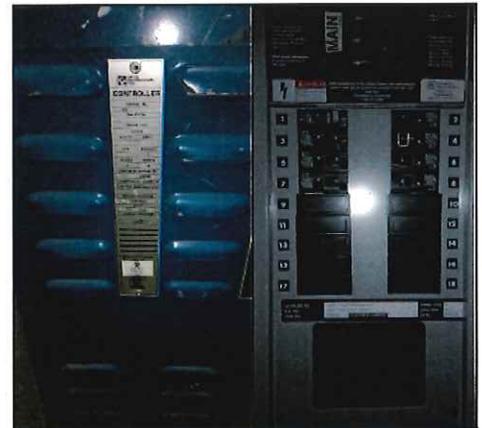
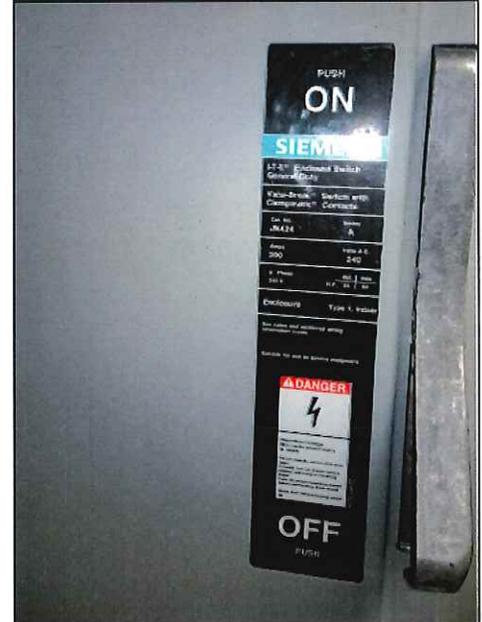
The elevator is a 30 HP hydraulic type elevator and has a 200 amp, 3 pole disconnect feeding it. The elevator controller was installed in 1995 based on nameplate data. The elevator machine room is fed from its own panelboard located in closet 3 #304 adjacent to the elevator machine room and is in good condition. The elevator machine room meets code, as it has devices required by the elevator code including the elevator disconnect with shunt trip breaker, heat detector, smoke detector, sprinkler head and a fan coil unit for conditioning of the space.

Elevator Controller, Panelboard and Disconnect

There are no recommendations for the existing elevator installation as it meets code requirements and is in good working order.

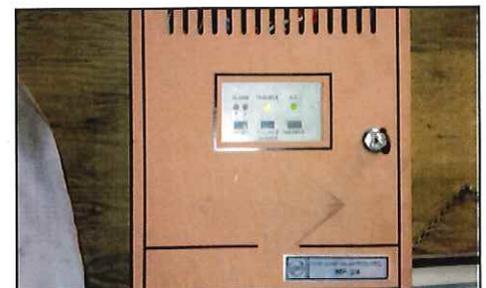
The existing fire alarm control panel is a Fire Lite Alarms Inc. panel which is old and dated. The existing panel had a trouble message during the survey. The fire alarm control panel should be replaced.

Fire Alarm Control Panel

Existing fire alarm system is old and dated and we recommend updating entire fire alarm system with new fully addressable building fire alarm system.
